# Fire Damage Restoration

## Case Study: Expert response allows church to fulfil commitments following fire.

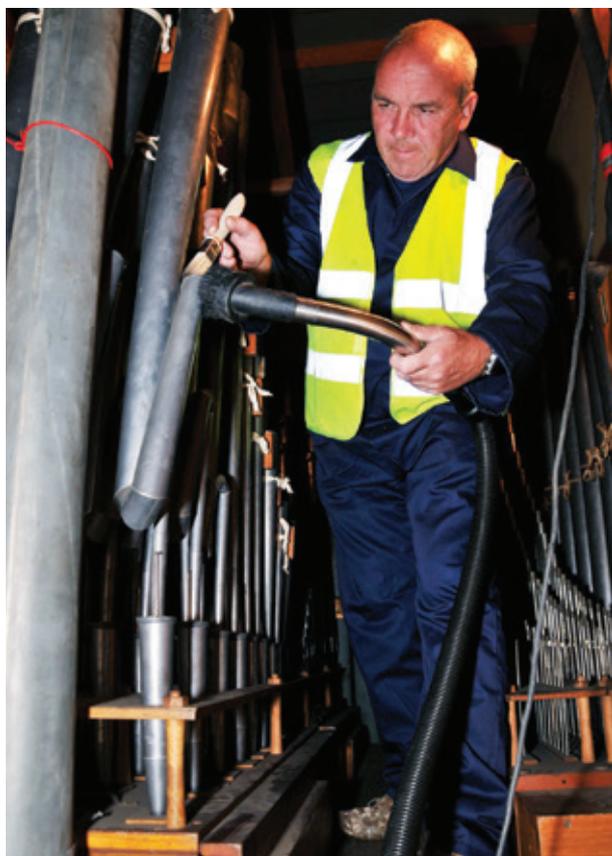
Throughout the night the carpet had smoldered and caused heavy carbon contamination to the building pillar adjacent to the fire. The entire church had been affected by smoke residues from the ceiling to the floor, leaving smoke stains to all surfaces throughout the building, thermal damage to the plaster and a heavy odour of smoke immediately present when entering the church. With a wedding booked at the church just two days later, time was of the essence to find a solution.

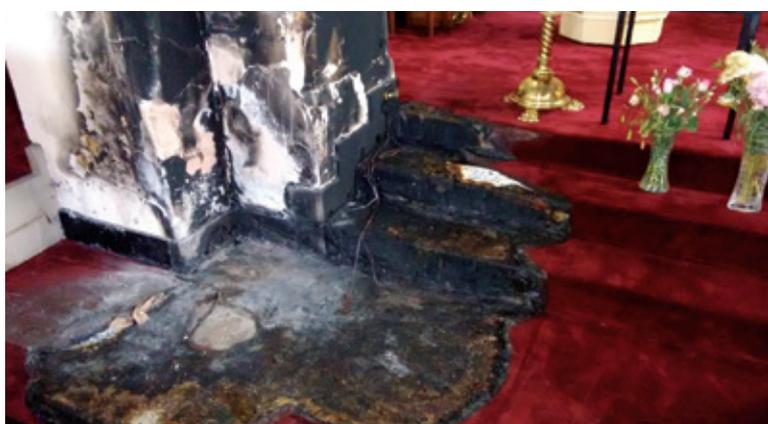
The church had sustained carbon staining and heavy smoke odour. The main archway was located close to the seat of the fire and consequently had been damaged. The Polygon technicians decontaminated this as a priority and then painted the entire arch to ensure that it was acceptable for the wedding the next day. The carpets required thorough decontamination to remove the substantial smoke odour. This was achieved by using a hot water extraction machine and deodorising solutions. As carbon particulate was settling within the building daily, filtered air movers were also installed.

The bespoke solution consisted of two days mitigation work, followed by ten days of work for the main decontamination process.

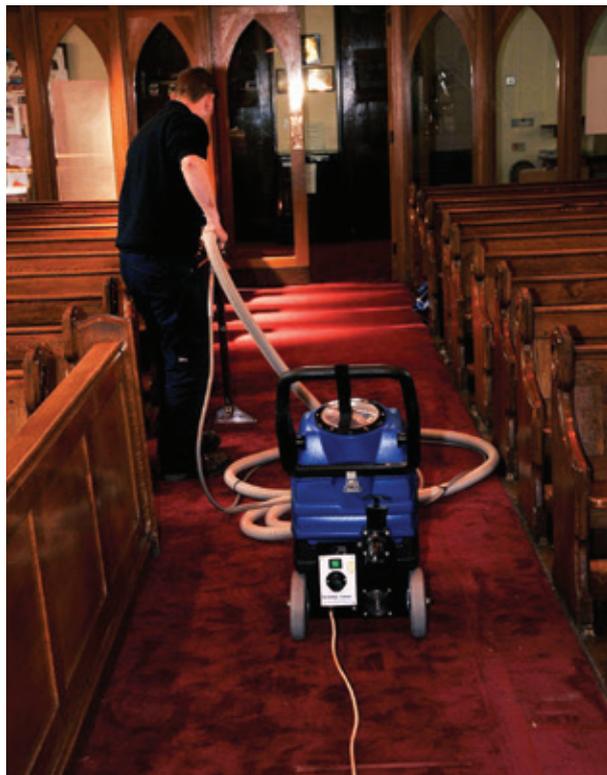
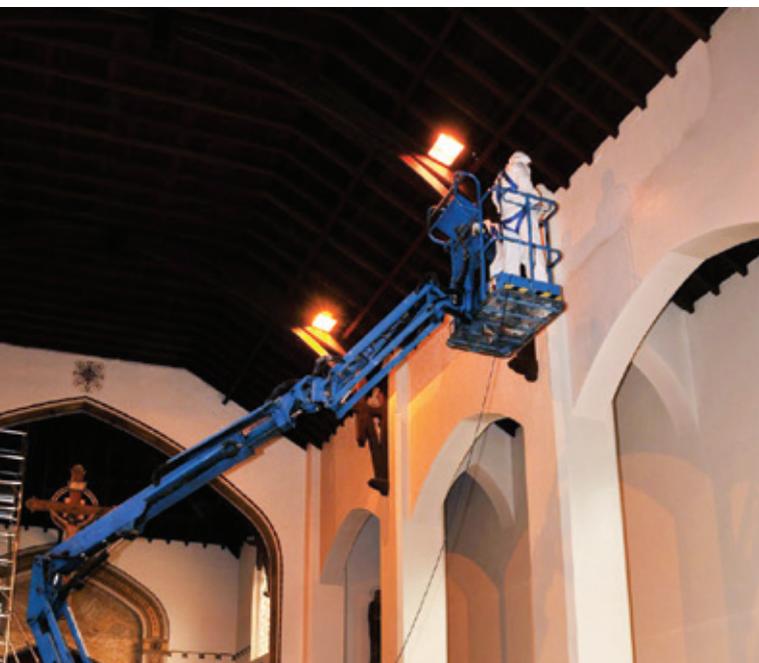
Following the decontamination process, the church was thoroughly deodorised to ensure any remaining residual smoke odours were eliminated. This was achieved through the use of fogging machines and deodorising chemicals. Polygon technicians then replastered the damaged column and decorated the church from ceiling to floor.
